The Preservationist

Summer 2021

REHABILITATING INTERIORS IN HISTORIC BUILDINGS (CONT.)

Identifying and Preserving Character-defining Elements

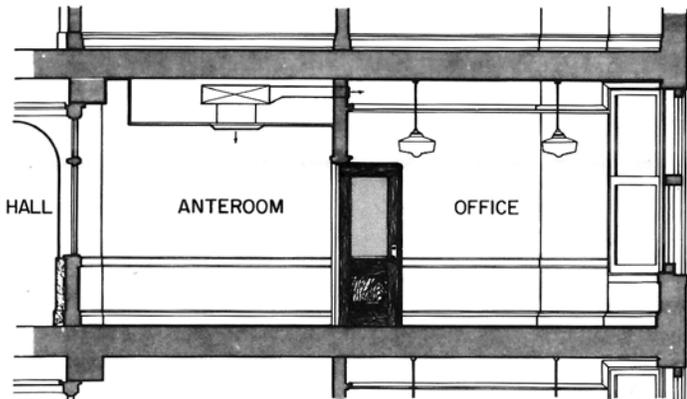
Figure 7. When the Monadnock Building was rehabilitated, architects retained the basic floor plan on the upper floors consisting of a double-loaded corridor with offices opening onto it. The original floor-to-ceiling height in the corridors and outside offices the most important spaces was maintained by installing needed air conditioning ductwork in the less important anterooms. In this way, the most significant interior spaces were preserved intact. Drawing by Neal A. Vogel

1. Retain and preserve floor plans and interior spaces that are important in defining the overall historic character of the building. This includes the size, configuration, proportion, and relationship of rooms and corridors; the relationship of features to spaces; and the spaces themselves such as lobbies, reception halls, entrance halls, double parlors, theaters, auditoriums, and important industrial or commercial use spaces. Put service functions required by the building's new use, such as bathrooms, mechanical equipment, and office machines, in secondary spaces.

2. A void subdividing spaces that are characteristic of a building type or style or that are directly associated with specific persons or patterns of events. Space may be subdivided both vertically through the insertion of new partitions or horizontally through insertion of new floors or mezzanines. The insertion of new additional floors should be considered only when they will not damage or destroy the structural system or obscure, damage, or destroy character-defining spaces, features, or finishes. If rooms have already been subdivided through an earlier insensitive renovation, consider removing the partitions and restoring the room to its original proportions and size.

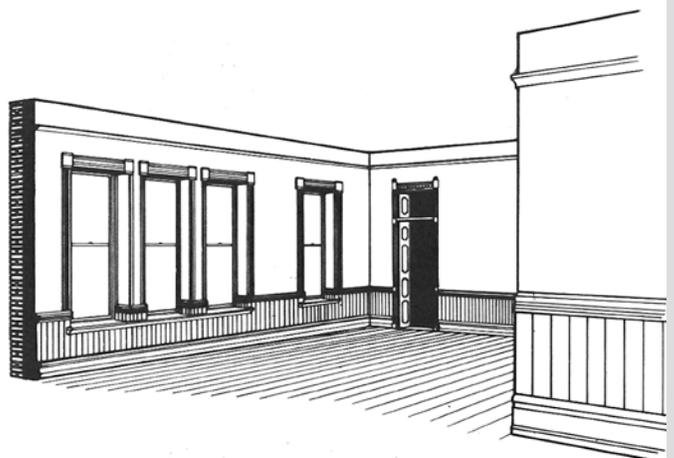
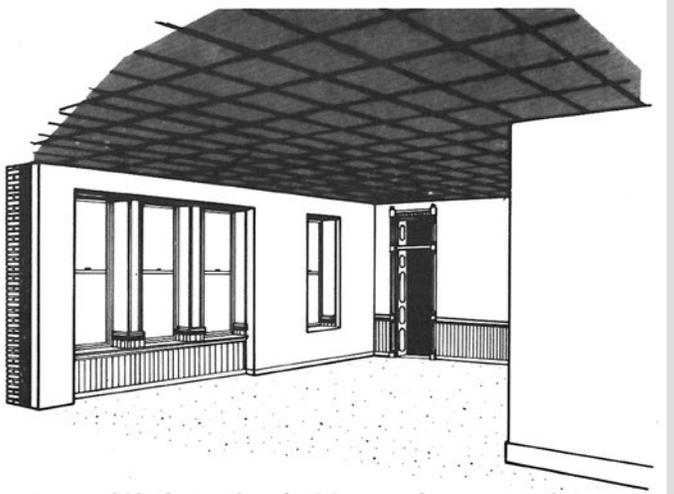
Figure 8. Furring out exterior walls to add insulation and suspending new ceilings to hide ductwork and wiring can change a room's proportions and can cause interior features to appear fragmented. In this case, a school was converted into apartments, and individual classrooms became living rooms, bedrooms, and kitchens. On the left is an illustration of a classroom prior to rehabilitation; note the generous floor-to-ceiling height, wood wainscoting, molded baseboard, picture molding, and Eastlake Style door and window trim. After rehabilitation, on the right, only fragments of the historic detailing survive: the ceiling has been dropped below the picture molding, the remaining wainscoting appears to be randomly placed, and some of the window trim has been obscured. Together with the subdivision of the classrooms, these rehabilitation treatments prevent a clear understanding of the original classroom's design and space. If thermal performance must be improved, alternatives to furring out walls and suspending new ceilings, such as installing insulation in attics and basements, should be considered. Drawings by Neal A. Vogel

4. Avoid installing dropped ceilings below ornamental ceilings or in rooms where high ceilings are part of the building's character. In addition to obscuring or destroying significant details, such treatments will also change the space's proportions. If dropped ceilings are installed in buildings that lack character-defining spaces, such as mills and factories, they should be well set back from the windows, so they are not visible from the exterior.

8. Avoid "furring out" perimeter walls for insulation purposes. This requires unnecessary removal of window trim and can change a room's proportions. Consider alternative means of improving thermal performance, such as installing insulation in attics and basements and adding storm windows.

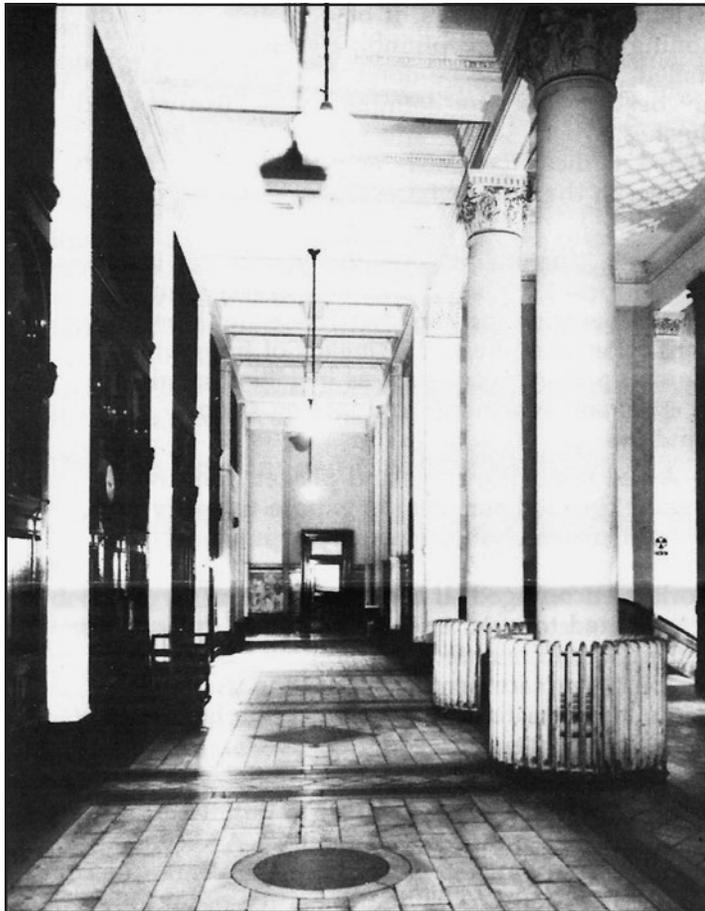
Figure 9. The tangible reminders of early mechanical systems can be worth saving. In this example, in the Old Post Office in Washington, D.C., radiators encircle Corinthian columns in a decorative manner. Note, too, the period light fixtures. These features were retained when the building was rehabilitated as retail and office space. Photo: Historic American Buildings Survey

7. Retain and preserve visible features of early mechanical systems that are important in defining the overall historic character of the building, such as radiators, vents, fans, grilles, plumbing fixtures, switch plates, and lights. If new heating, air conditioning, lighting and plumbing systems are installed, they should be done in a way that does not destroy character-defining spaces, features, and finishes. Ducts, pipes, and wiring should be installed as inconspicuously as possible: in secondary spaces, in the attic or basement if possible, or in closets.

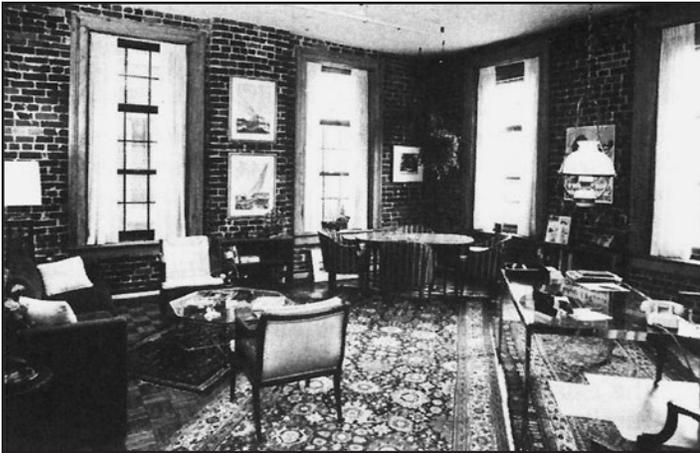
Figure 10. In this case plaster has been removed from perimeter walls, leaving brick exposed. In removing finishes from historic masonry walls, not only is there a loss of historic finish, but raw, unfinished walls are exposed, giving the interior an appearance it never had. Here, the exposed brick is of poor quality and the mortar joints are wide and badly struck. Plaster should have been retained and repaired, as necessary.

9. Avoid removing paint and plaster from traditionally finished surfaces, to expose masonry and wood. Conversely, avoid painting previously unpainted millwork. Repairing deteriorated plasterwork is encouraged. If the plaster is too deteriorated to save, and the walls and ceilings are not highly ornamented, gypsum board may be an acceptable replacement material. The use of paint colors appropriate to the period of the building's construction is encouraged.

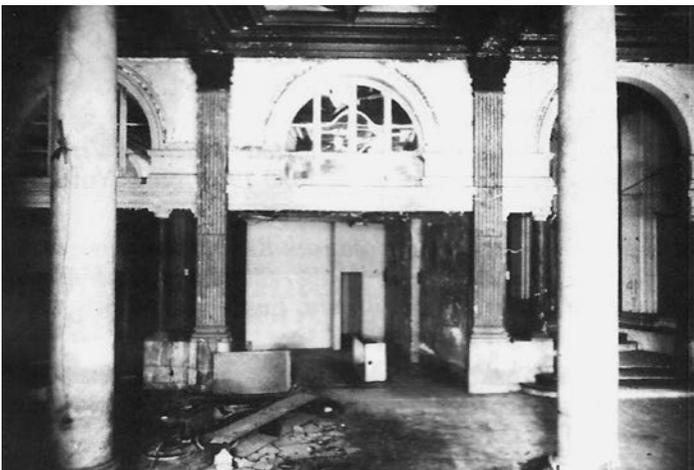
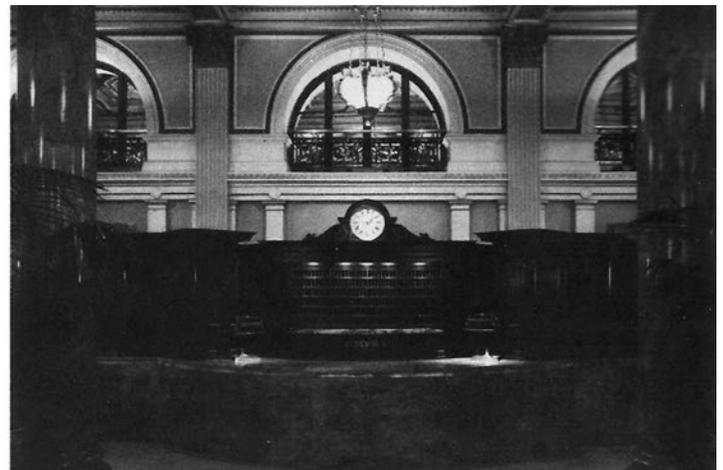
Figure 11. These dramatic "before" and "after" photographs show a severely deteriorated space restored to its original elegance: plaster has been repaired and painted; the scagliola columns have been restored to match marble using traditional craft techniques and missing decorative metalwork has been reinstalled in front of the windows. Although some reorganization of the space took place, notably the relocation of the front desk, the overall historic character of the space has been preserved. These views are of the lobby in the Willard Hotel, Washington, D.C. Credit: Commercial Photographers (left); Carol M. Highsmith (right)
